Lost Creek ISR, LLC
Littleton, Colorado USA

FIGURE 1.2-2
Solution Flow Patterns
Lost Creek Permit Area

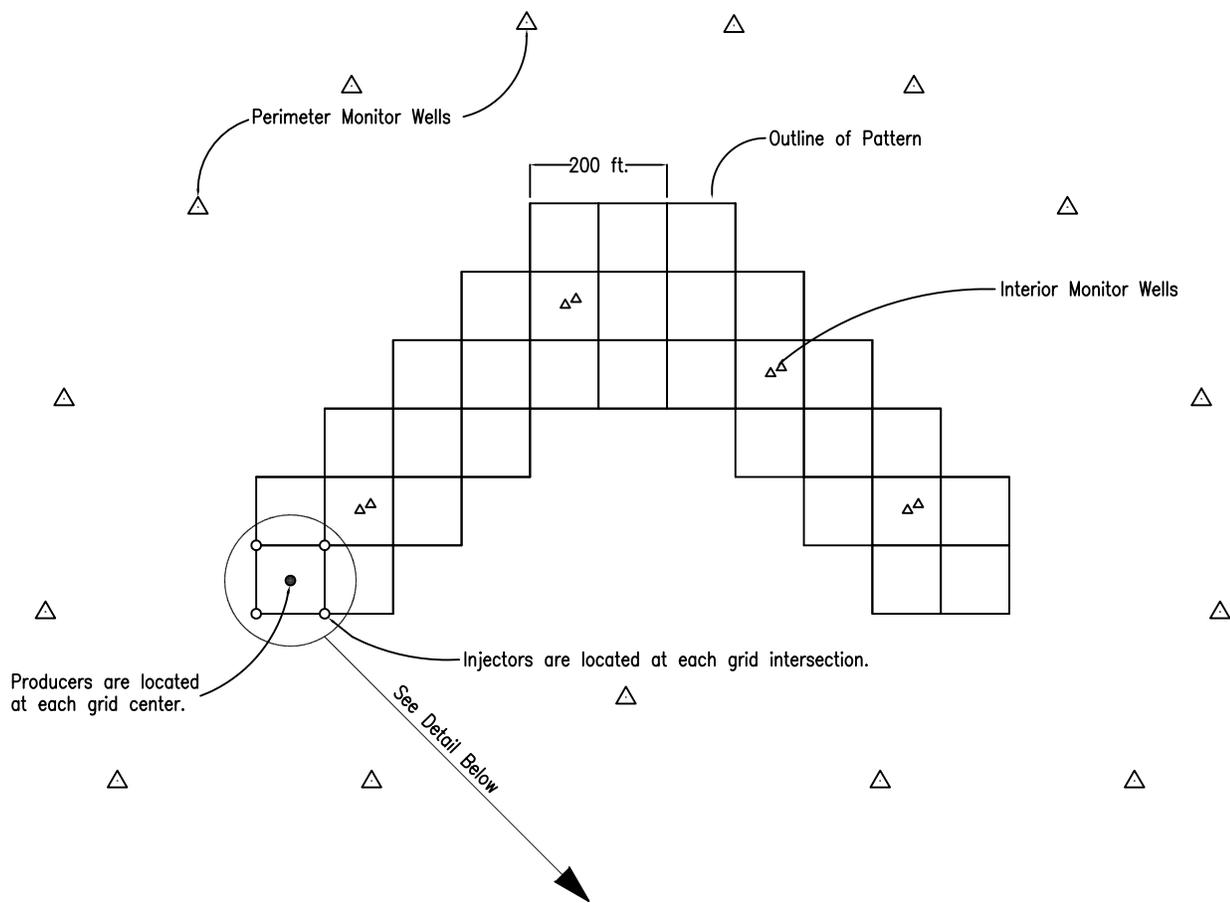
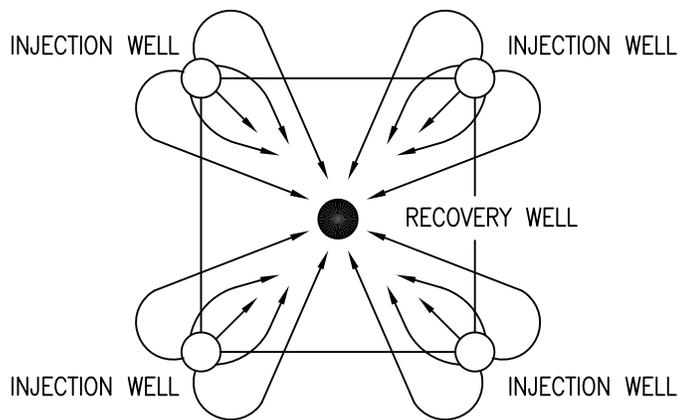
TYPICAL WELLFIELD PATTERN
