ATTACHMENT OP-5a

**Order 1 Soil Survey
Lost Creek Project - Plant Site
September 2008**

FIGURE OP-5a-1
Detailed Soil Survey Map Plant Site,
September 2008
Lost Creek Project

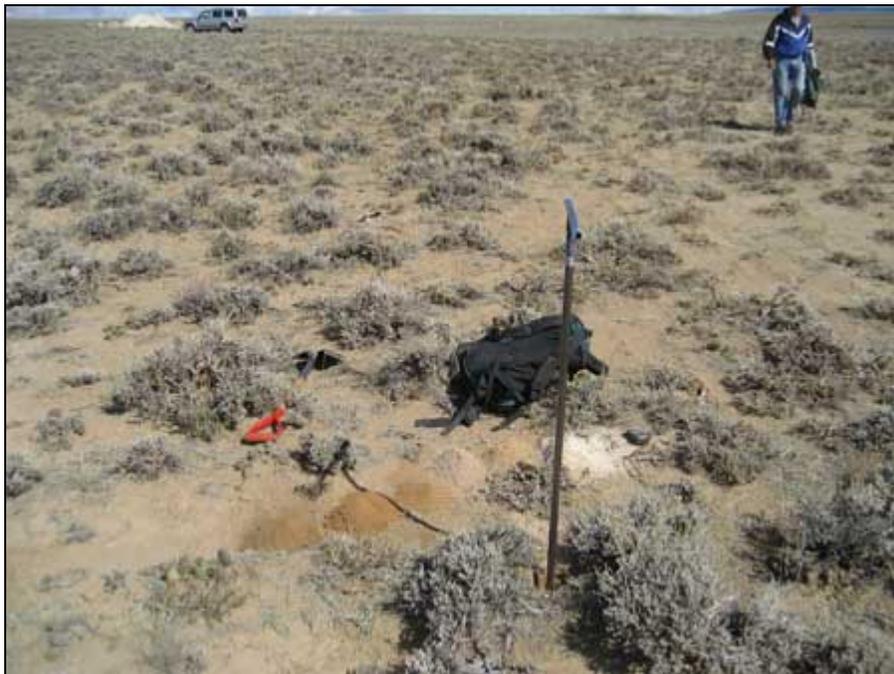
Mine Unit 1 Pit 33 (Expanded to soil profile & sampled). Plant Site. Elevation 6985 ft. Vegetation on site had 50% ground cover, including 40% sage, 5% grasses & 5% litter. Site was relatively undisturbed. Drilled to depth of 36 in.

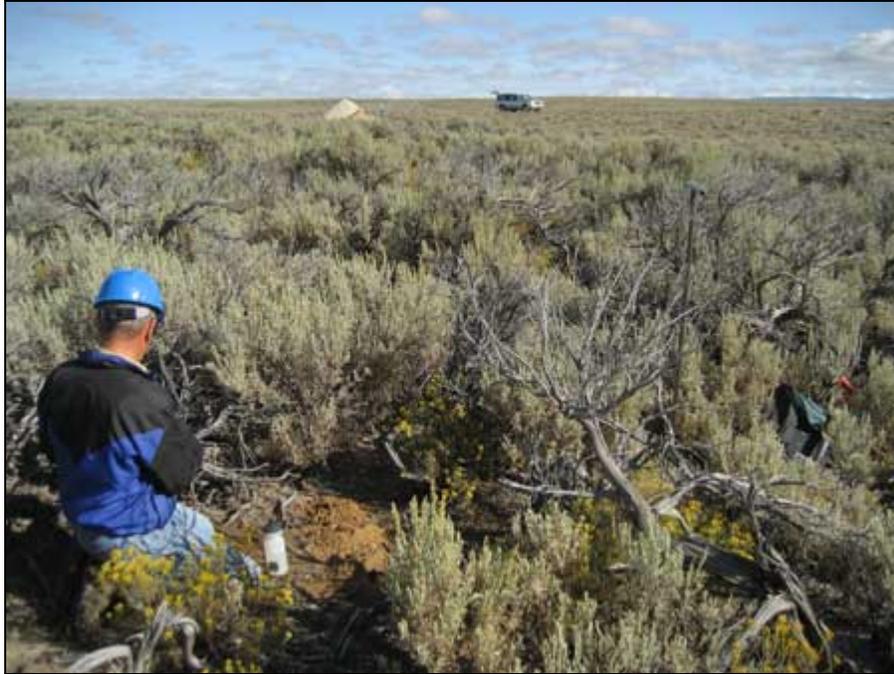
Mine Unit 1 Pit 35 (Expanded to soil profile & sampled.) Plant Site. Elevation 6978 ft. Vegetation on site had 85% ground cover, including 80% large sage to 4 ft high & 5% other vegetation. Picture was taken in the undisturbed terrain west of Mine Unit 1 Pit 29 in the swale. Site was undisturbed. Drilled to depth of 24 in.
