Lost Creek ISR, LLC
Littleton, Colorado USA

FIGURE 6.2-1
Restoration Flow Diagram

Lost Creek Permit Area

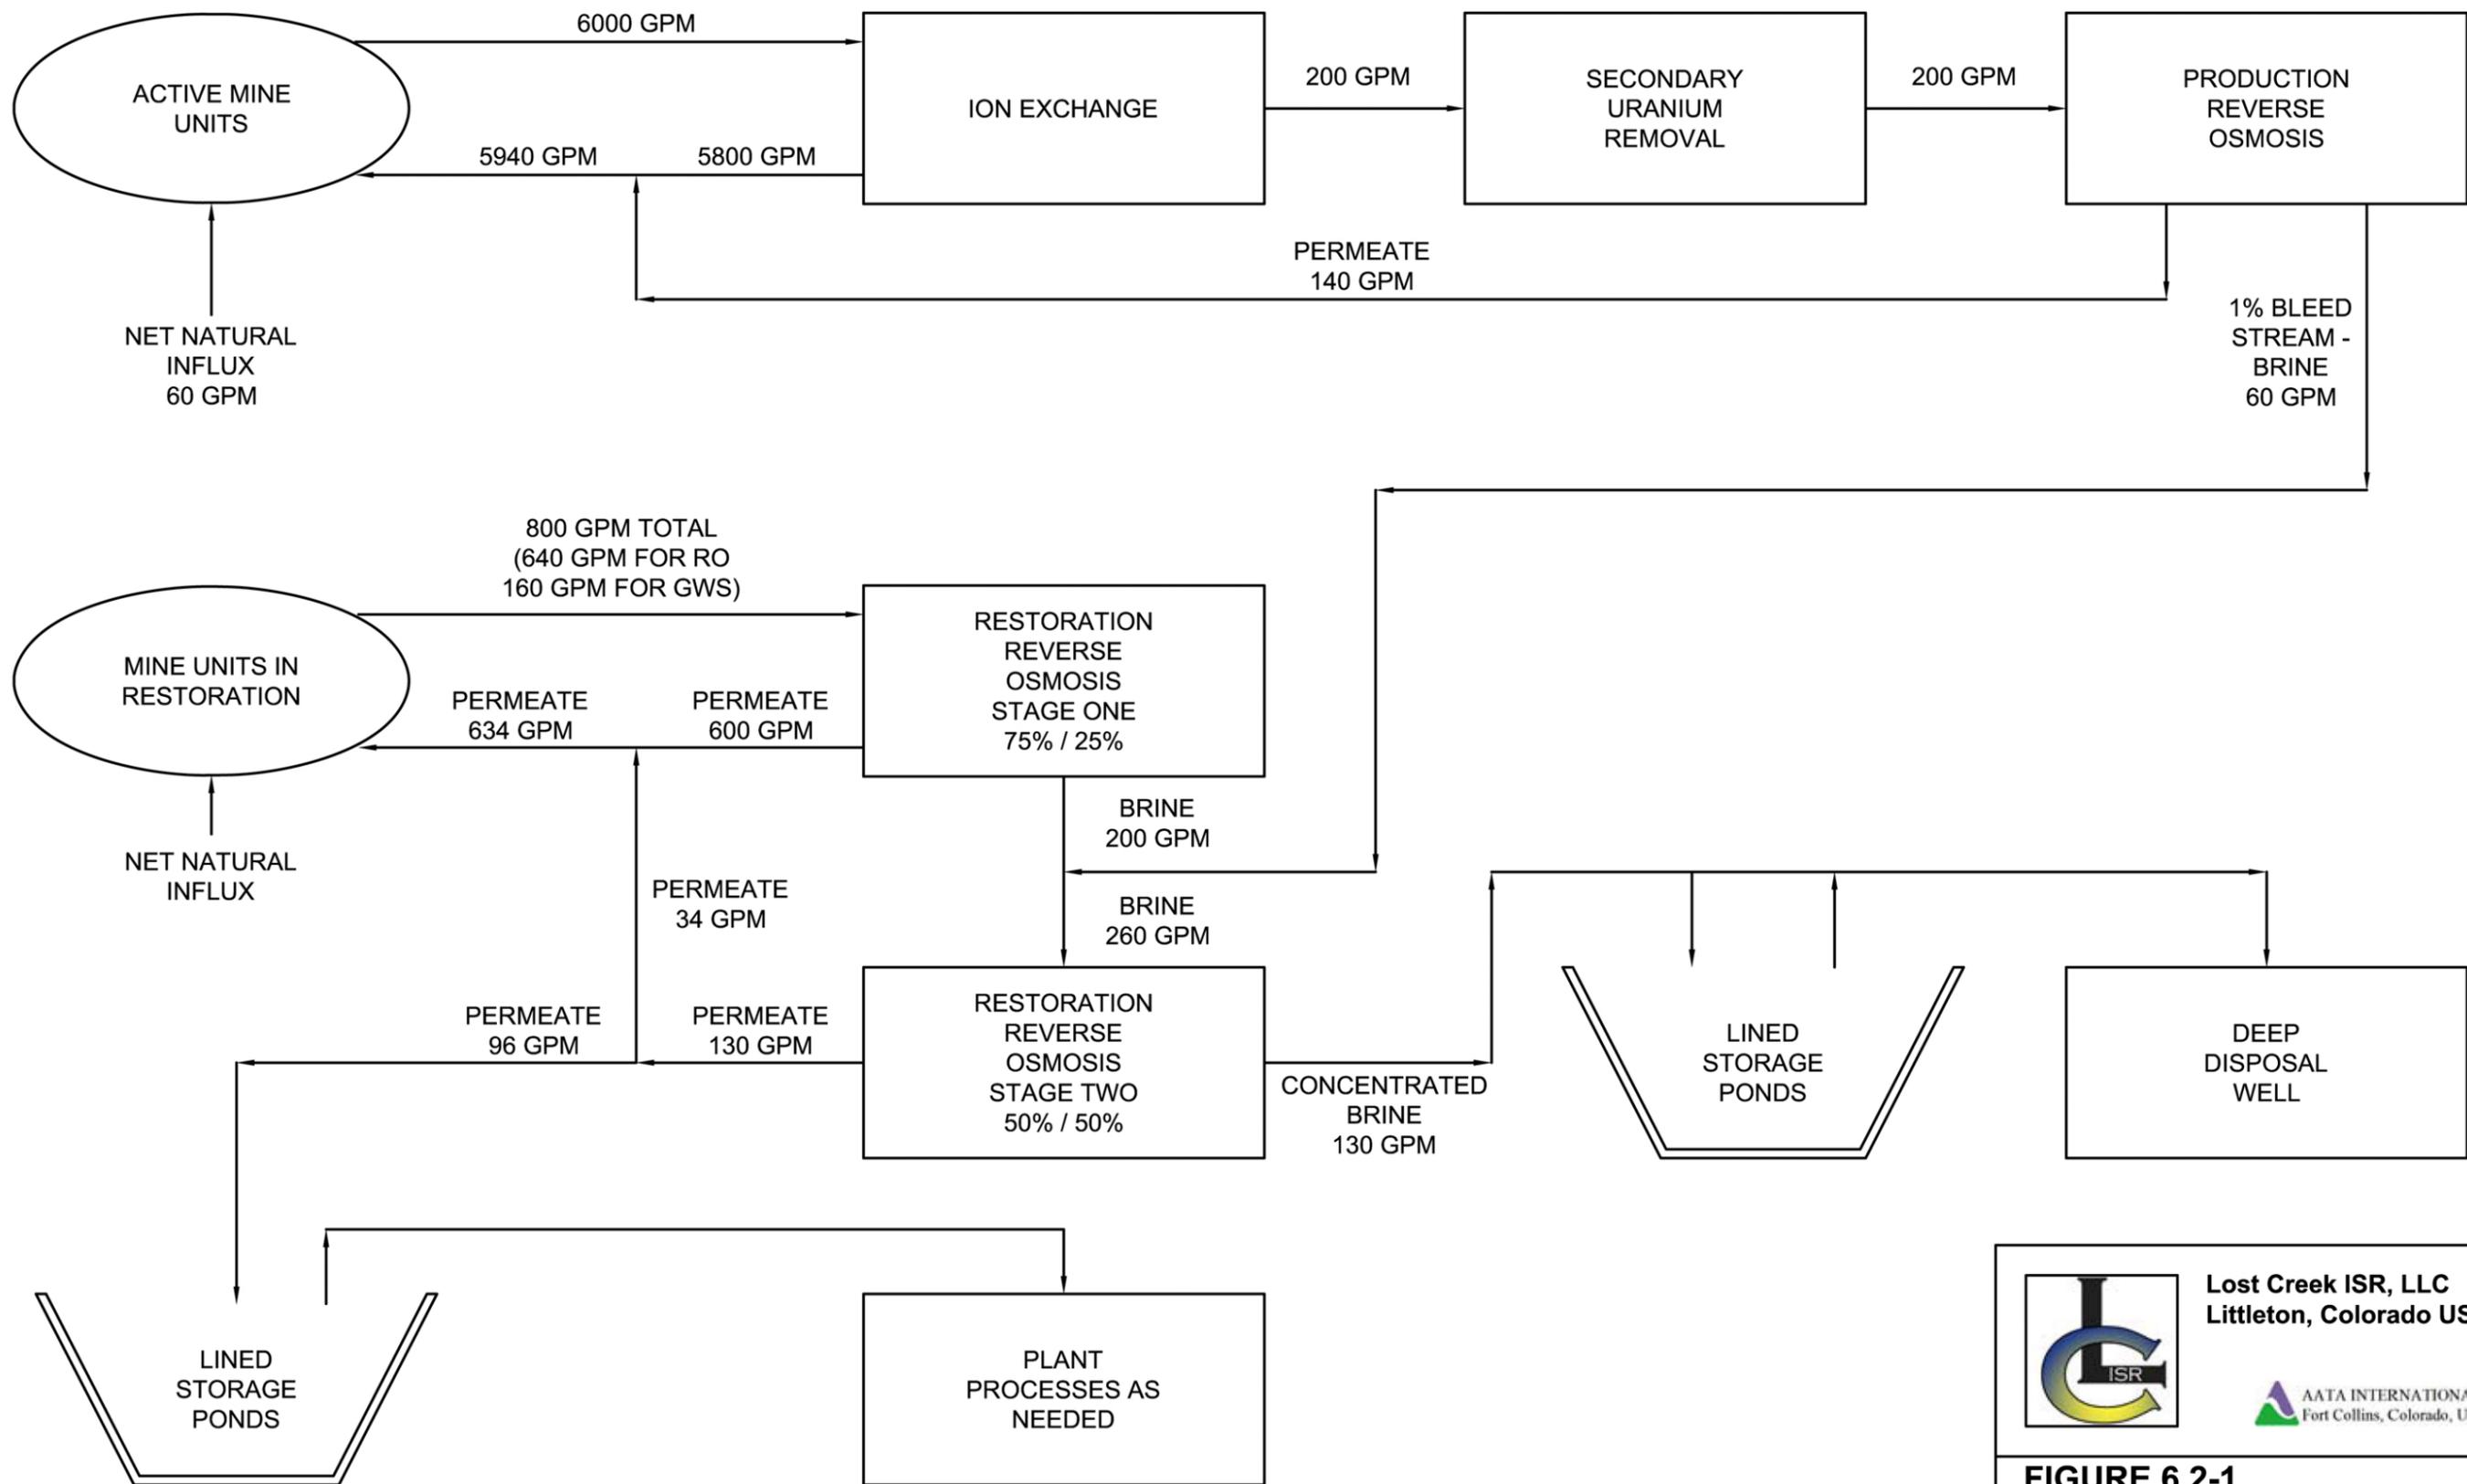
MINE UNIT OPERATIONS AT 6,000 GPM WITH A 1% BLEED (60 GPM)
